ANN ARBOR TOWNSHIP

Standard Specifications and Details

SOIL EROSION DETAILS

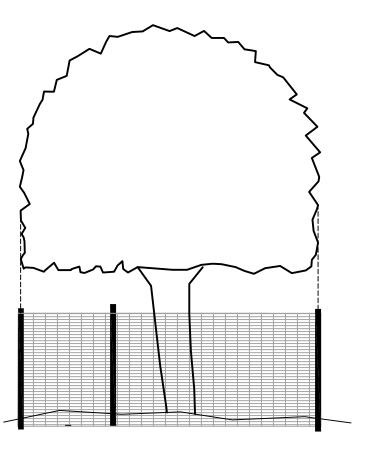
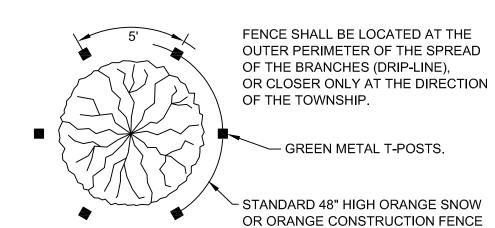
TREE PROTECTION FENCE DETAIL

- 1. ALL TREES TO BE REMOVED WILL BE INDENTIFIED
- BY RED FLAGGING.

2. TREE PROTECTION FENCING IS TO BE ERECTED PRIOR TO ANY EARTHWORK OR CONSTRUCTION AND IS TO REMAIN IN PLACE UNTIL CONSTRUCTION
- AND GRADING IS COMPLETE.

3. ALL DEBRIS, FILL, EQUIPMENT OR MATERIAL IS TO BE KEPT CLEAR OF AREA WITHIN PROTECTIVE FENCE. NO CLEANING OF EQUIPMENT OR MATERIAL OR STORAGE OR DISPOSAL OF ANY MATERIAL WITHIN THE DRIP LINE OF ANY TREES TO BE SAVED.
