Impacts of Sediment Discharge on Massey Lake

Results from 2025 Investigation

Ann Arbor Charter Township

December 8, 2025

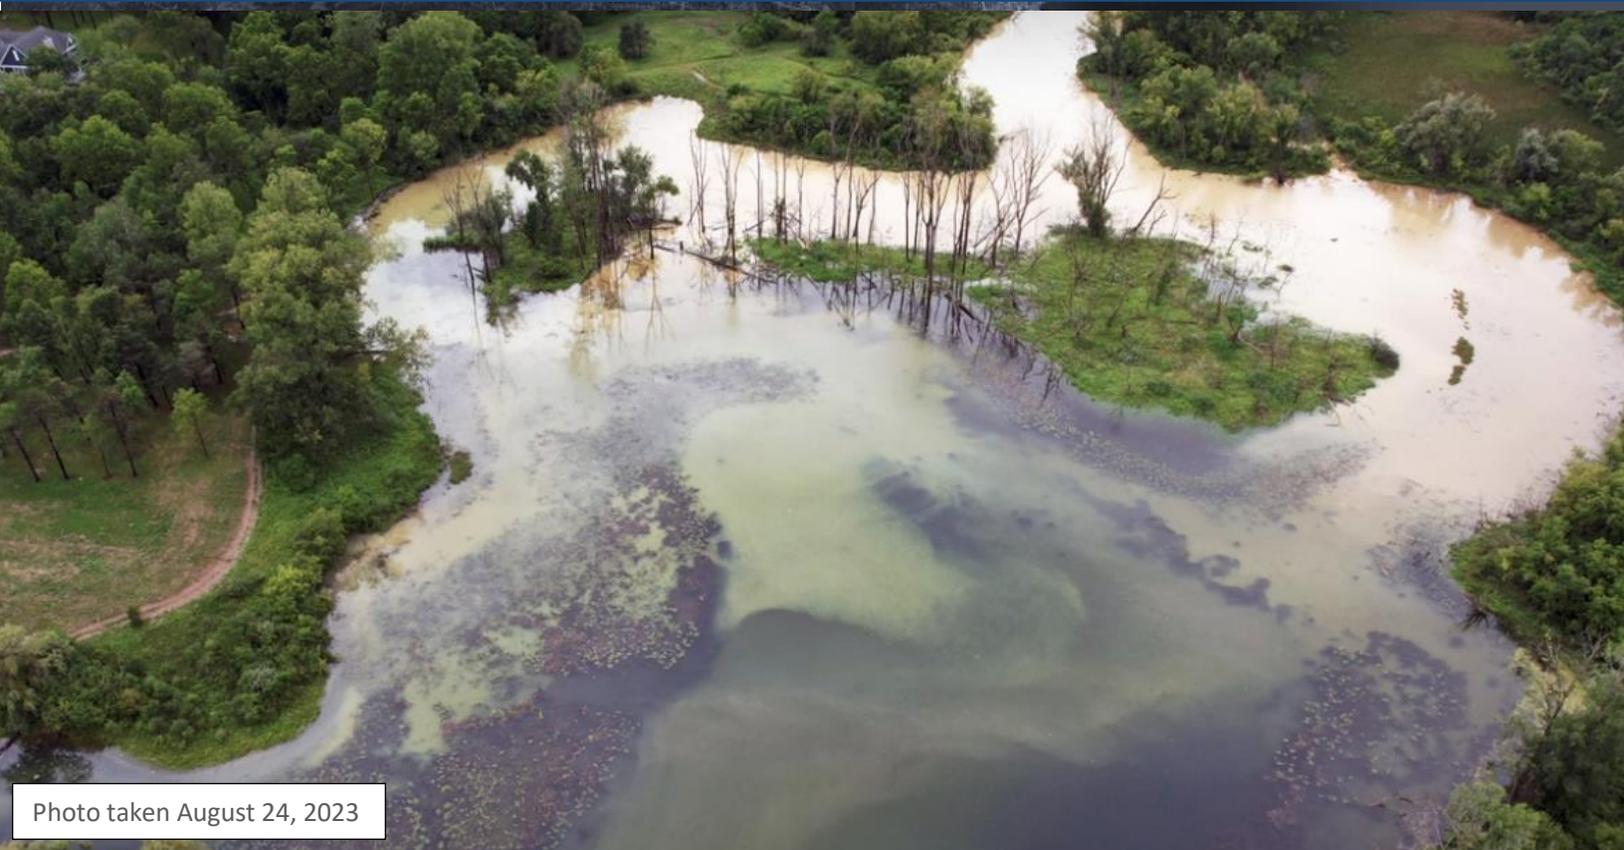
Photo taken August 24, 2023

Cover image: drone photo of Massey Lake taken on August 24, 2023, showing turbid water entering the lake from gravel pit dewatering discharge upstream of the lake (photo credit: Michael Watts). Turbid conditions in the lake ceased after pit dewatering discharge stopped.

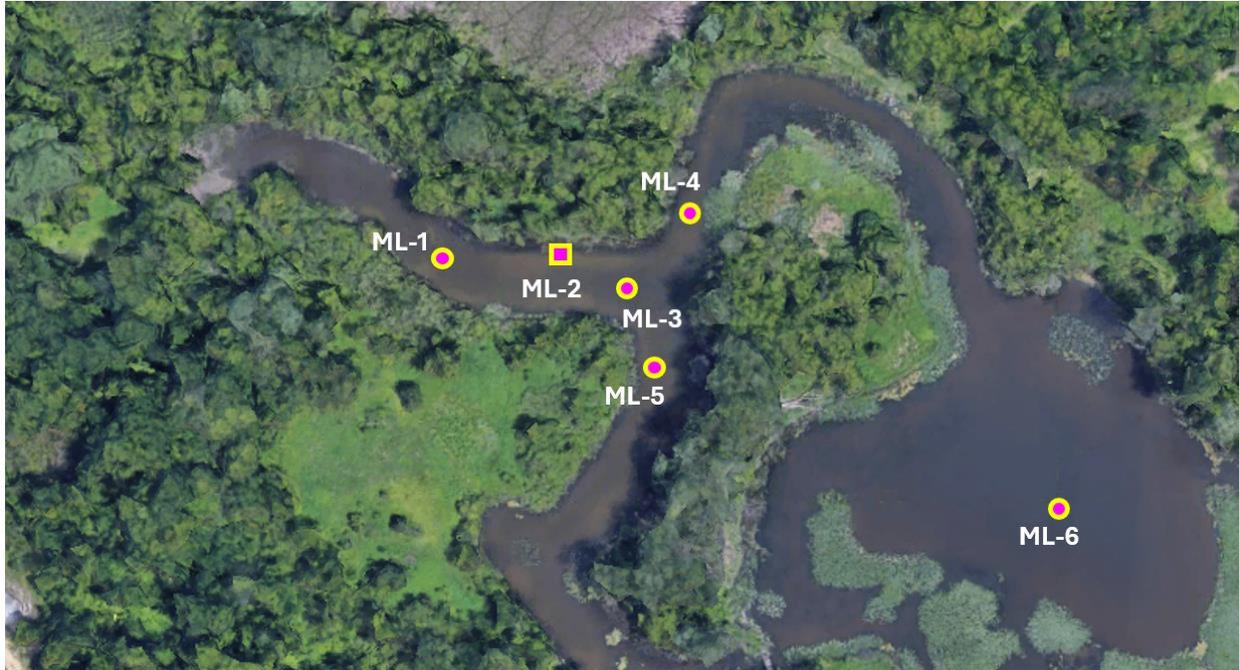
Sampling locations (Figure 2) were selected with consideration for where the signal of potential impacts would be strongest. That is, most samples were collected in the area of the lake west of the large island that received direct influx of sediment from the creek into which gravel pit effluent was discharged (see the report cover photo). Paired samples were collected at each site to compare recent sediments at the lake bed with older sediments that were more deeply buried and unlikely to be impacted by gravel pit discharges. Surface (S) and subsurface sediments (D for “deep”) were sampled at six Massey Lake (ML) locations, with sediment depths, water depths, and site coordinates shown in Table 1 and depicted on Figure 2. Five of the sites were near the creek inlet (ML-1 through ML-5, Figure 2). A reference site, ML-6, was located in the center of the lake on the east side of the large island in an area less likely to be strongly influenced by sediment deposits from gravel pit discharges due to settling of particles closer to the inlet. This site was included for comparison purposes with sediment analyses from the other sites, as well as to provide information on the water column properties in the open lake.

Figure 2. 2025 sediment sampling locations (approximate).

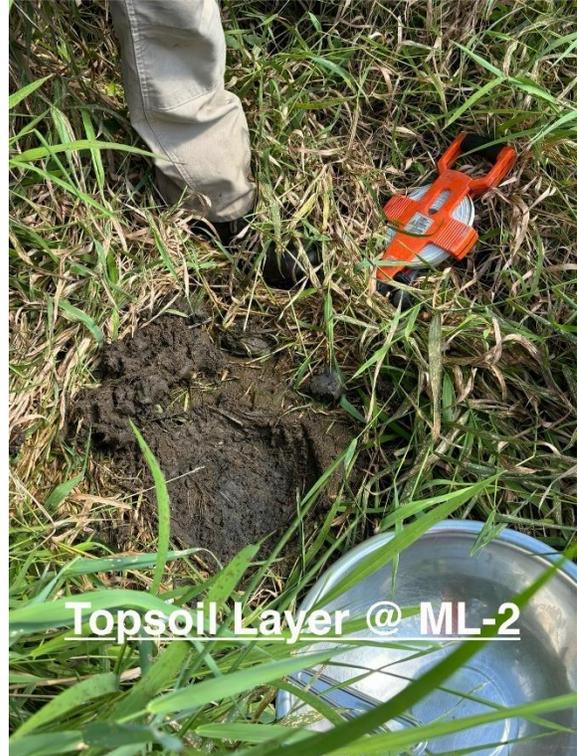
Topsoil Layer @ ML-2

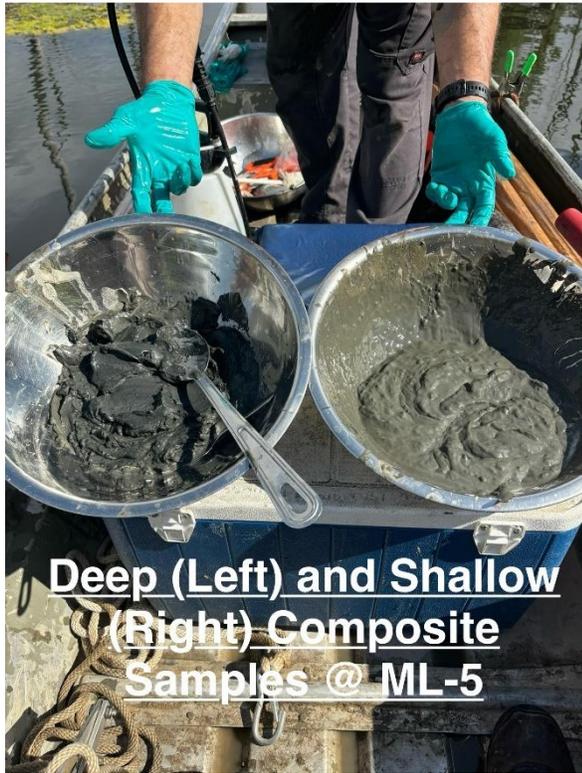
**Deep (Left) and Shallow
(Right) Composite
Samples @ ML-5**
